Inspection Report Minerals Regulatory Program January 31, 2013

Mine Name: Red Summit Mine	Permit Number: S/043/0031
Operator Name: PABCO Building Products, LLC	Inspection Date: November 03, 2010
Inspector(s): L Heppler	Time: 12:00 PM
Other Participants: Company Representative	Mine Status: Active

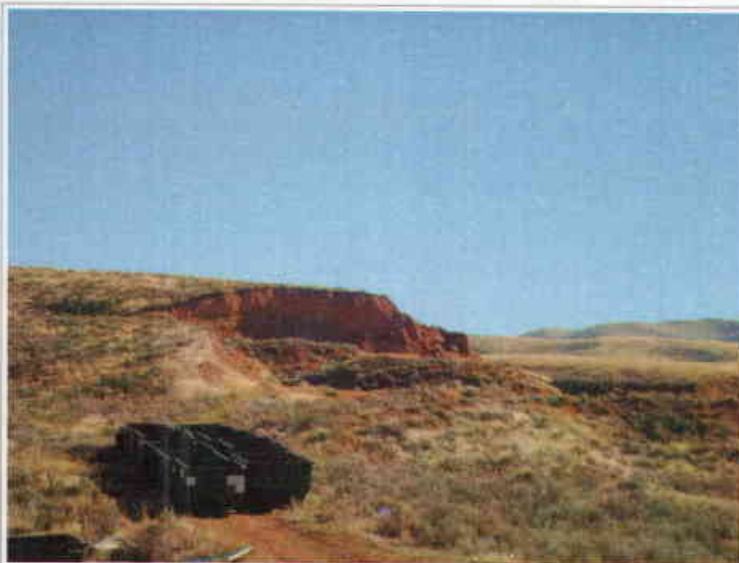
Overview from access road

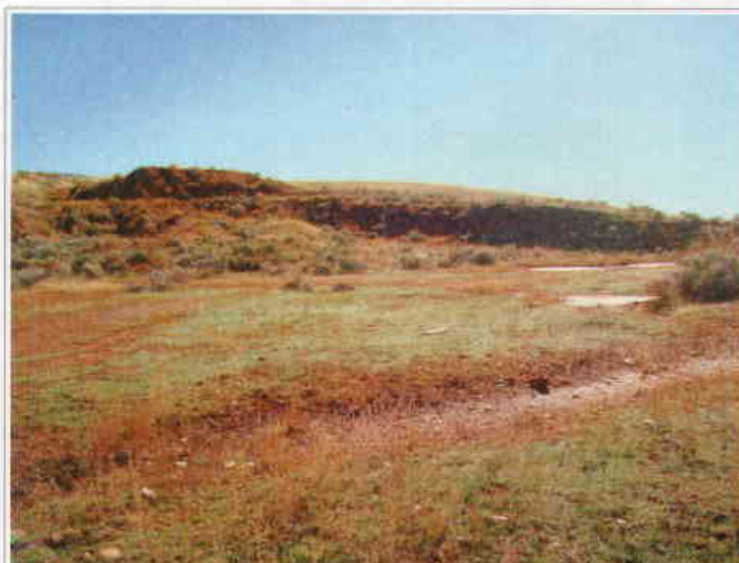
Lower disturbed level

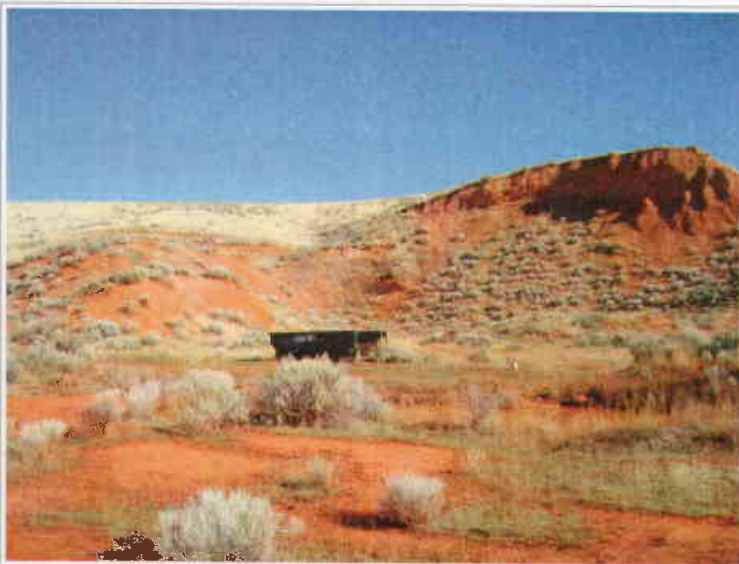
Waste dump on left of photo

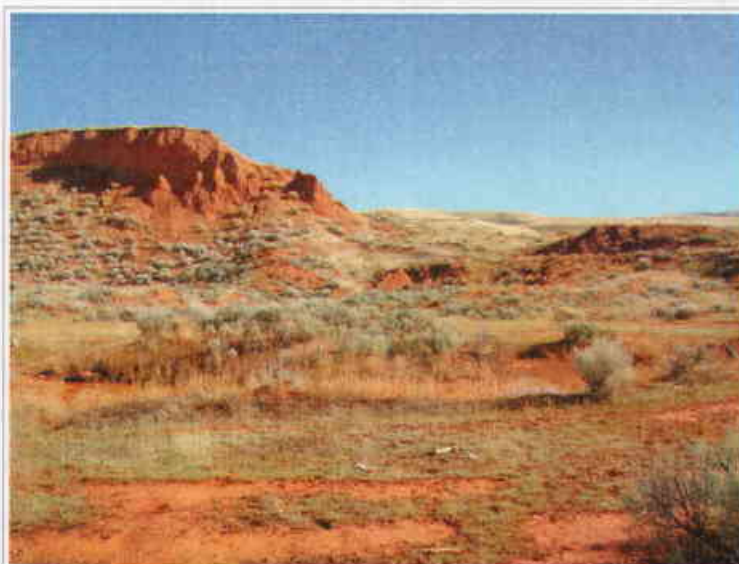
Inspection Summary: Toured the mine and surrounding area. There is a large high wall that is oversteepened and up to the property line, making future reclamation difficult. Much of the disturbance is historic; google earth photos go back to 1993, but UGS has older airphotos on file.

Over steepened highwall

Conclusions and Recommendations: Bond amount is past due for escalation. Operator has the option of updating map and reducing disturbed acres. OGM to continue annual inspections and monitor the site when in the area.
